2016 Annual Inspection Report

**Barataria Bay Waterway West
Shoreline Protection**

State Project Number BA-23
Priority Project List 4

July 11, 2016
Jefferson Parish

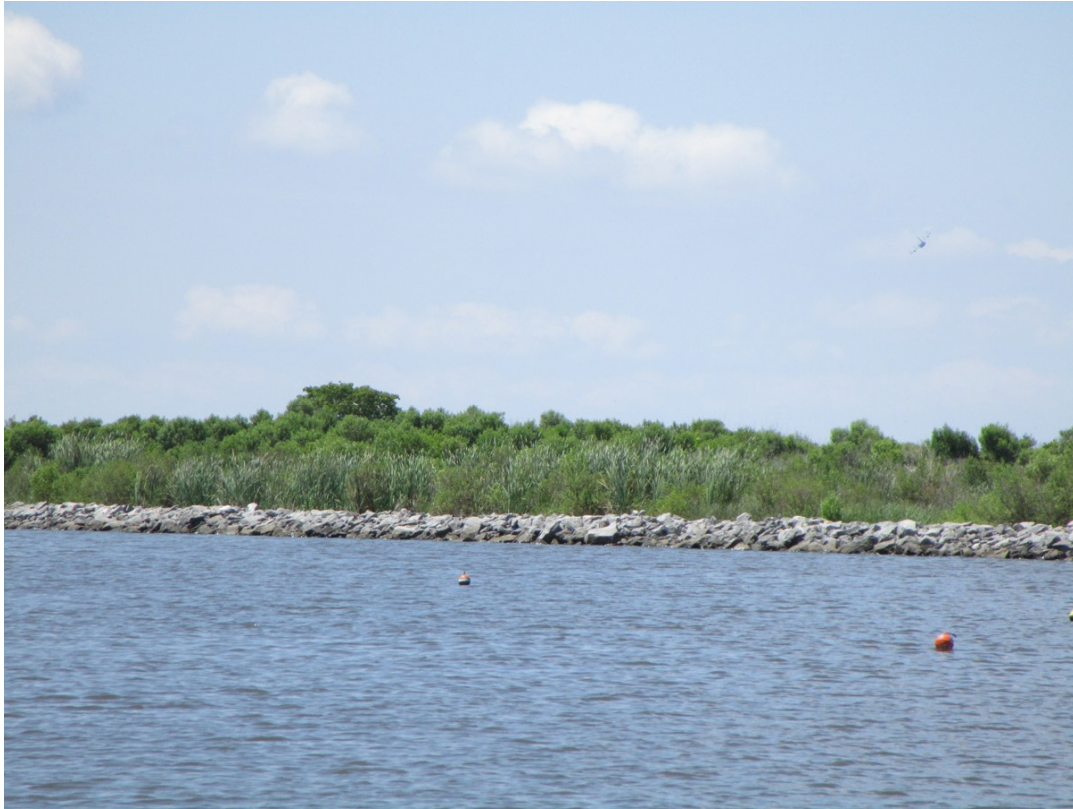
Photo #1 – Shoreline Protection

The rock structure appeared to be in good condition at the time of the inspection (Photo #1). There are some sections which have experienced settlement, but the structure is still functioning as designed. These sections will continue to be monitored for maintenance needs.

- Continue to check the WCS during operational procedures.
- Continue to observe rock structure for settlement.

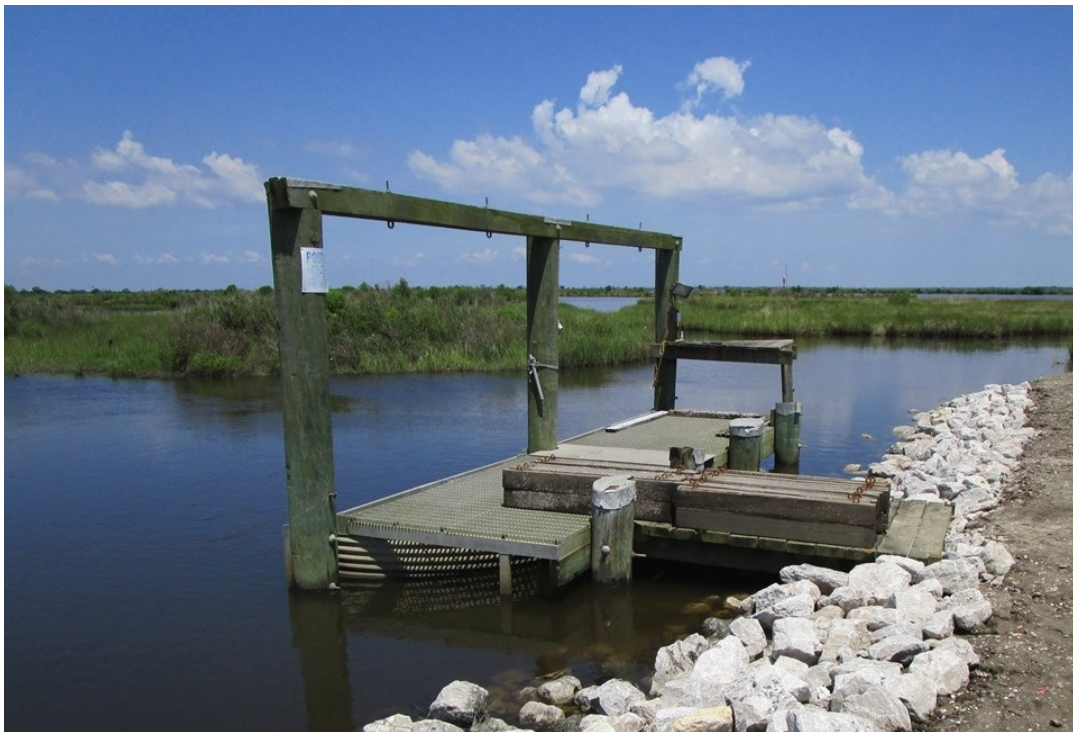
Photo #2 – Water Control Structure

The WCS was restored to fully-functional status following the 2016 maintenance repairs (Photos #2, #3, & #4). Riprap placed on the marsh side of the structure is anticipated to provide additional erosion protection.
